Other Significant Observations

Although the Board now understands the combination of technical and organizational factors that contributed to the *Columbia* accident, the investigation did not immediately zero in on the causes identified in previous chapters. Instead, the Board explored a number of avenues and topics that, in the end, were not directly related to the cause of this accident. Nonetheless, these forays revealed technical, safety, and cultural issues that could impact the Space Shuttle Program, and, more broadly, the future of human space flight. The significant issues listed in this chapter are potentially serious matters that should be addressed by NASA because they fall into the category of “weak signals” that could be indications of future problems.

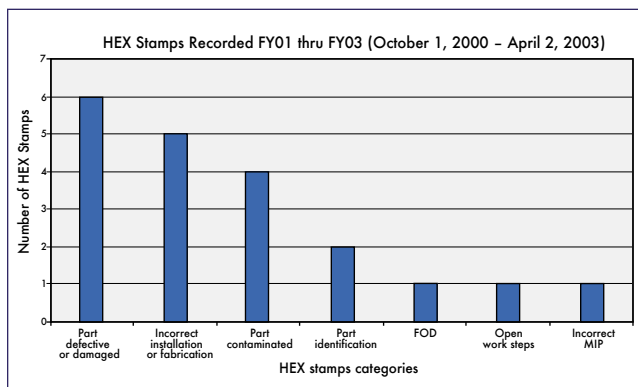
Of the 141,127 inspections subject to rejection from October 2000 through March 2003, only 20 rejections, or "hexes," were recorded, resulting in a statistically improbable discrepancy rate of .014 percent (see Figure 10.4-4). In interviews, technicians and inspectors alike confirmed the dubiousness of this rate. NASA's published rejection rate therefore indicates either inadequate documentation or an underused system. Testimony further revealed incidents of quality assurance inspectors being played against each other to accept work that had originally been refused.

Figure 10.4-4. Rejection, or "Hex" stamps issued from October 2000 through April 2003.
